# Microsoft Band 2 Wrist Clasp Replacement

Replacing the primary spring in the small square section of the clasp in order to allow the band to lock together and be wearable.

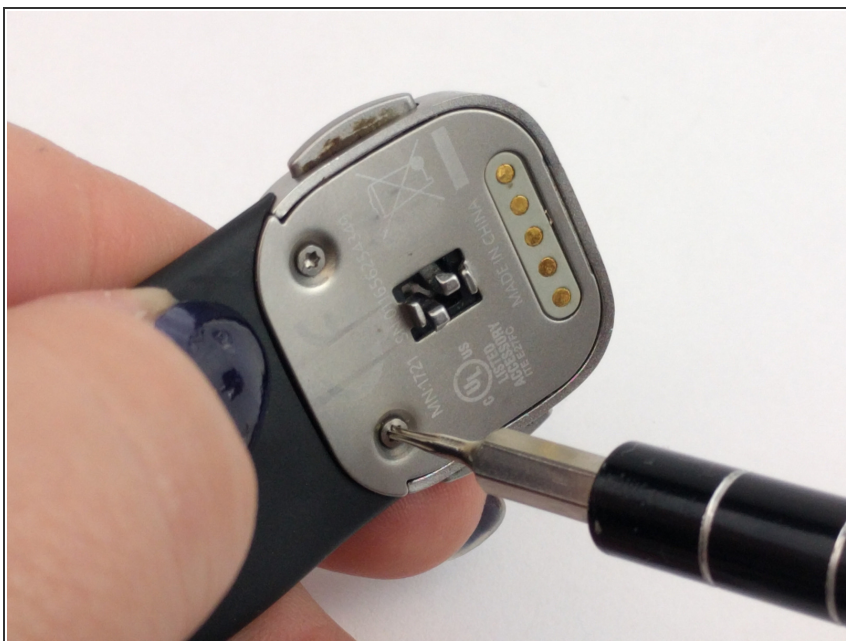
## Step 1 — Wrist Clasp

- Use the T3 screwdriver to remove the two 2mm screws in the device. The top metal panel should come off with ease once the screws have been removed.

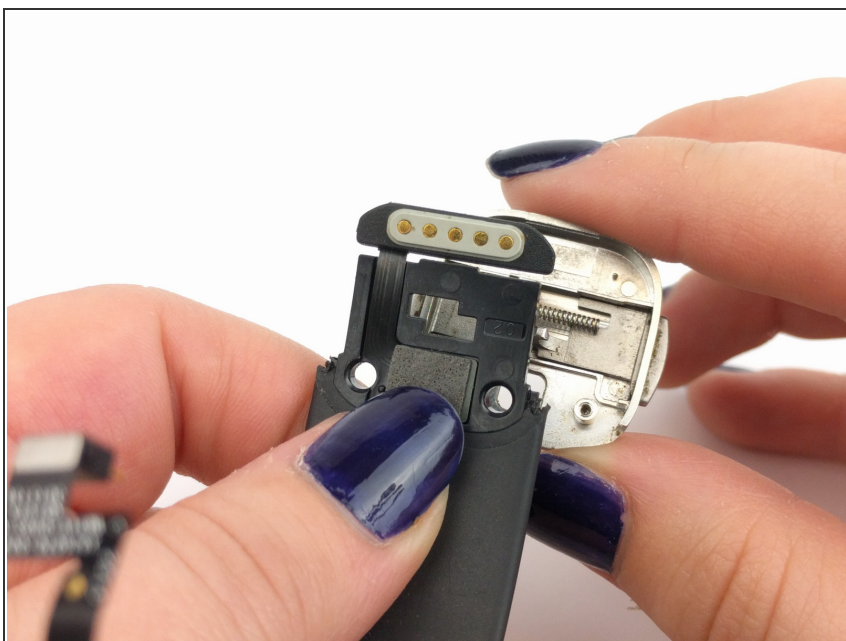
## Step 2

- Separate the watch band from the bottom metal panel.
- ⓘ There is a spring underneath the watch band that may break loose.

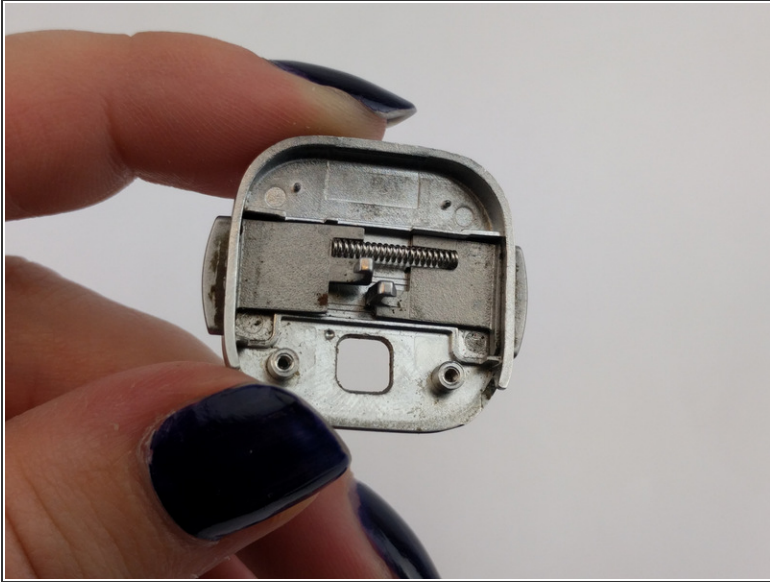
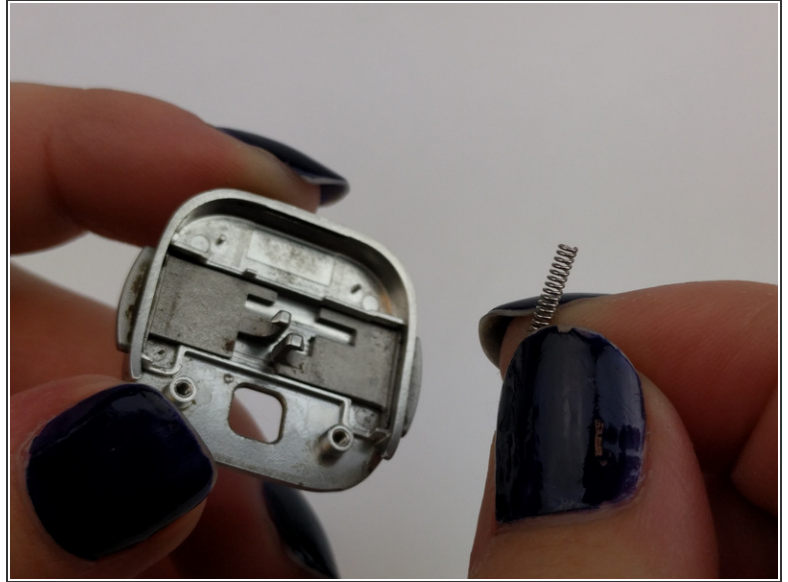
## Step 3

- Remove the spring.
